Exterior Architectural Finishes in Puerto Rico: The Painting Traditions of Guayama's Vernacular Architecture

Betty L. Prime
University of Pennsylvania

Prime, Betty L., "Exterior Architectural Finishes in Puerto Rico: The Painting Traditions of Guayama's Vernacular Architecture" (2011). *Theses (Historic Preservation)*. 164.
http://repository.upenn.edu/hp_theses/164

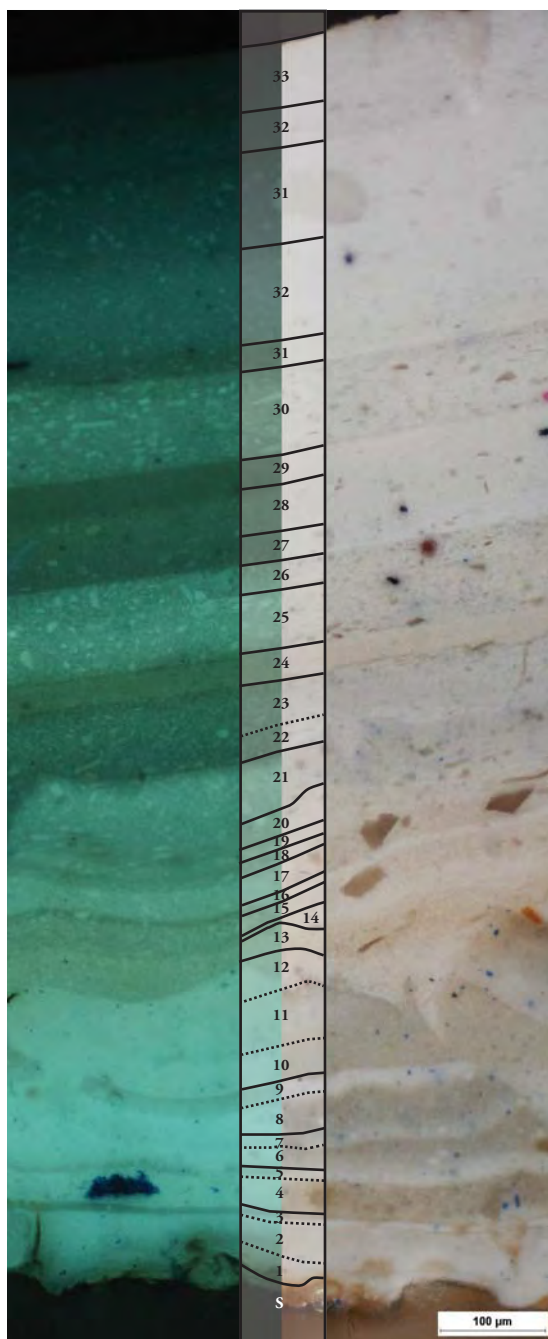
3 Ashford Street

Sample Number: 3 :G: 1	Element: door frame	Date Sampled: 02/12/11
Sample Location: south, left side top		Date Analyzed: 04/06/11
Substrate: wood	Illumination: Fluorescence BV 1A, Reflected/Quartz Halogen	
Microscope: Nikon ALPHAPHOT2-YS2		Objective: 10x
Analysis Performed by: Betty Prime		Camera: Nikon DS-Fi1

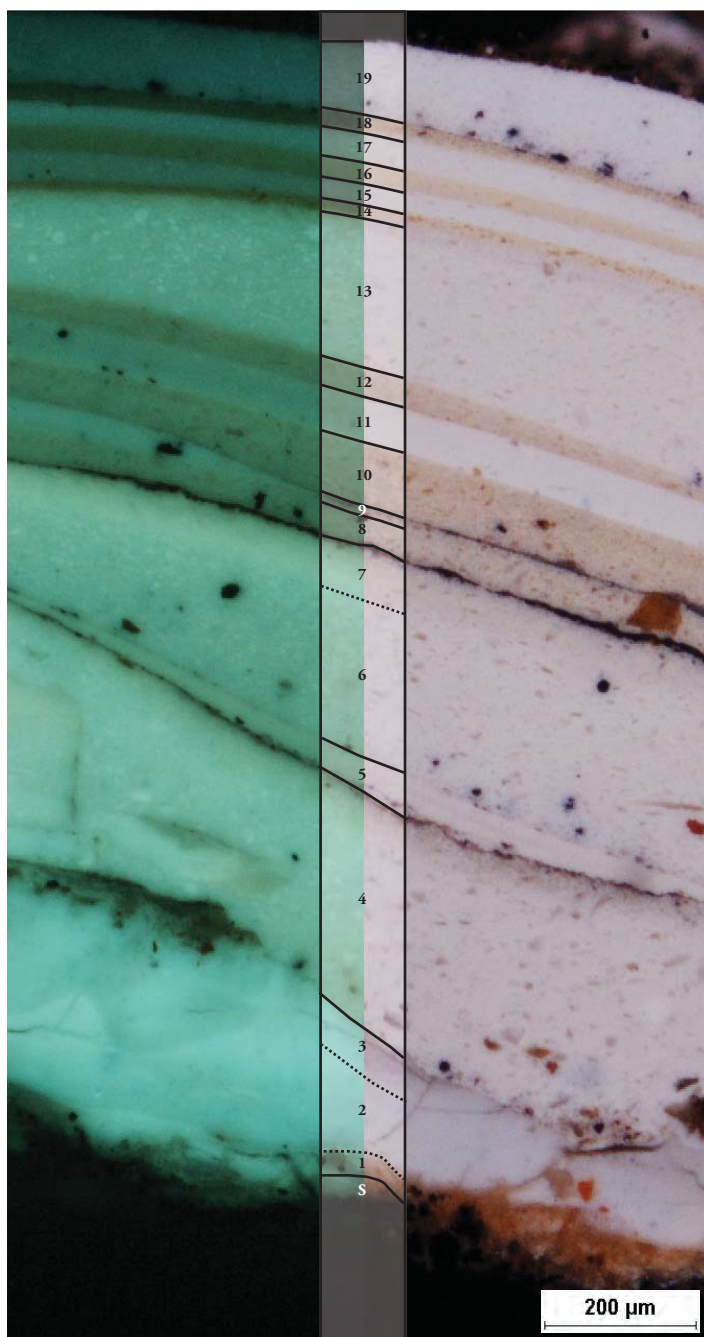
3 Ashford Street

Sample Number: 3 :G: 4	Element: door frame	Date Sampled: 02/12/11
Sample Location: pediment, top		Date Analyzed: 04/06/11
Substrate: wood	Illumination: Fluorescence BV 1A, Reflected/Quartz Halogen	
Microscope: Nikon ALPHAPHOT2-YS2		Objective: 4x
Analysis Performed by: Betty Prime		Camera: Nikon DS-Fi1

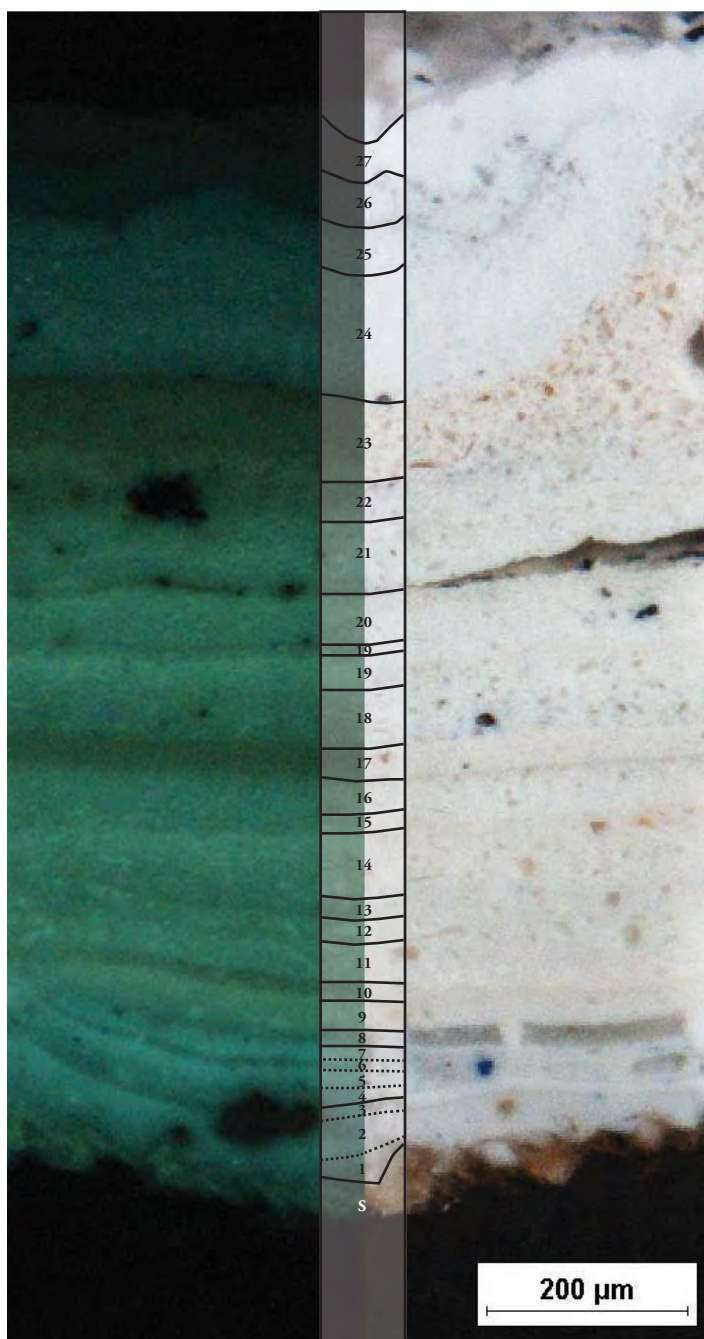
3 Ashford Street

Sample Number: 3 :H: 4	Element: cornice/soffit	Date Sampled: 02/12/11
Sample Location: bottom of cornice		Date Analyzed: 04/06/11
Substrate: wood	Illumination: Fluorescence BV 1A, Reflected/Quartz Halogen	
Microscope: Nikon ALPHAPHOT2-YS2		Objective: 4x
Analysis Performed by: Betty Prime		Camera: Nikon DS-Fi1

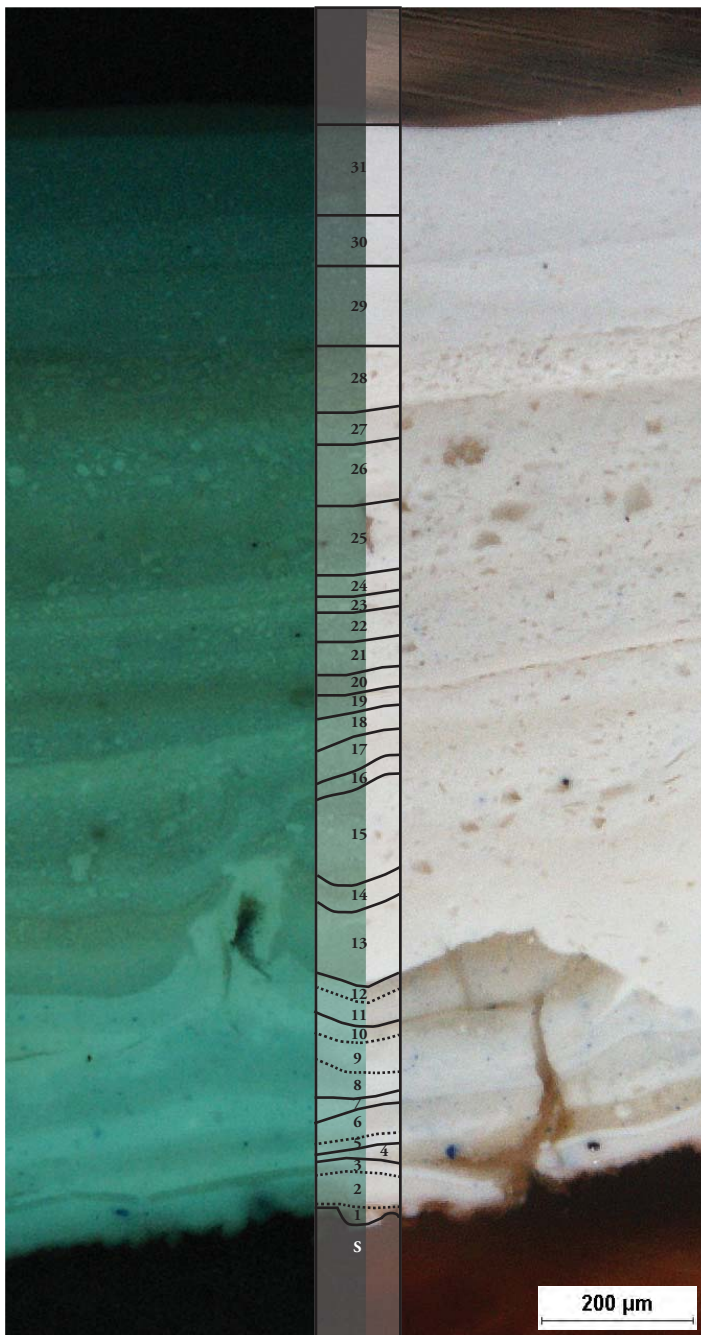
Guayama, Puerto Rico
3 Ashford Street

Sample Number: 3 :L: 3	Element: ceiling	Date Sampled: 02/12/11
Sample Location: above south door		Date Analyzed: 04/06/11
Substrate: wood	Illumination: Fluorescence BV 1A, Reflected/Quartz Halogen	
Microscope: Nikon ALPHAPHOT2-YS2		Objective: 4x
Analysis Performed by: Betty Prime		Camera: Nikon DS-Fi1

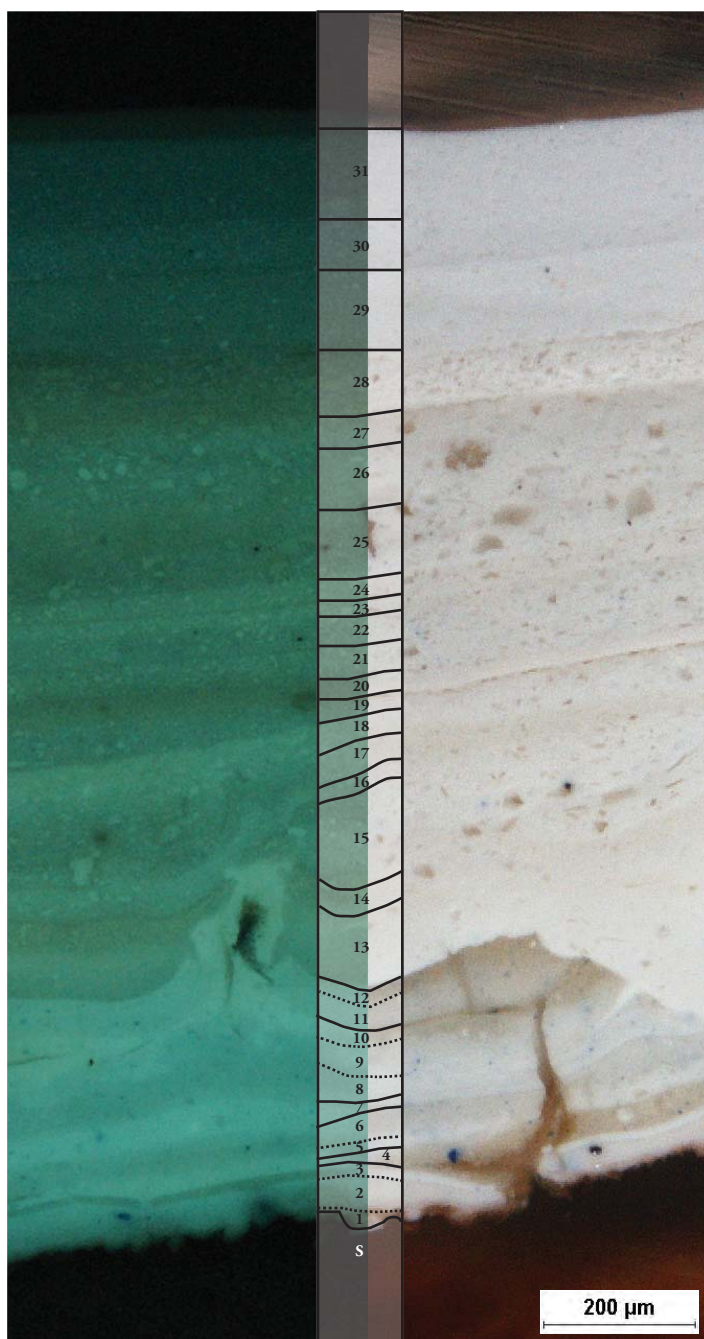
3 Ashford Street

Sample Number: 3 :L: 3	Element: ceiling	Date Sampled: 02/12/11
Sample Location: above south door		Date Analyzed: 04/06/11
Substrate: wood	Illumination: Fluorescence BV 1A, Reflected/Quartz Halogen	
Microscope: Nikon ALPHAPHOT2-YS2		Objective: 4x
Analysis Performed by: Betty Prime		Camera: Nikon DS-Fi1

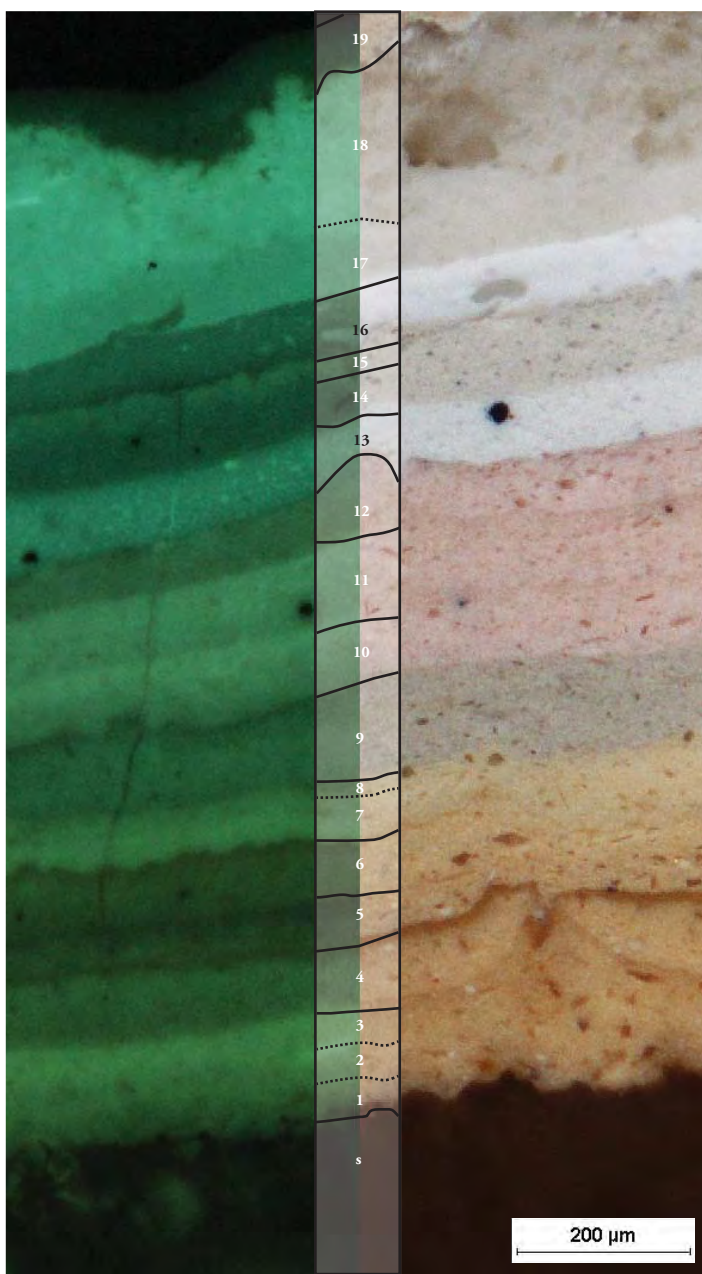
Guayama, Puerto Rico
48 N. Santiago Palmer Street

Sample Number: 48 :A: 1	Element: wall	Date Sampled: 02/13/11
Sample Location: siding adjacent to door		Date Analyzed: 03/25/11
Substrate: wood	Illumination: Reflected/Quartz Halogen	
Microscope: Nikon ALPHAPHOT2-YS2		Objective: 4x
Analysis Performed by: Betty Prime		Camera: Nikon DS-Fi1

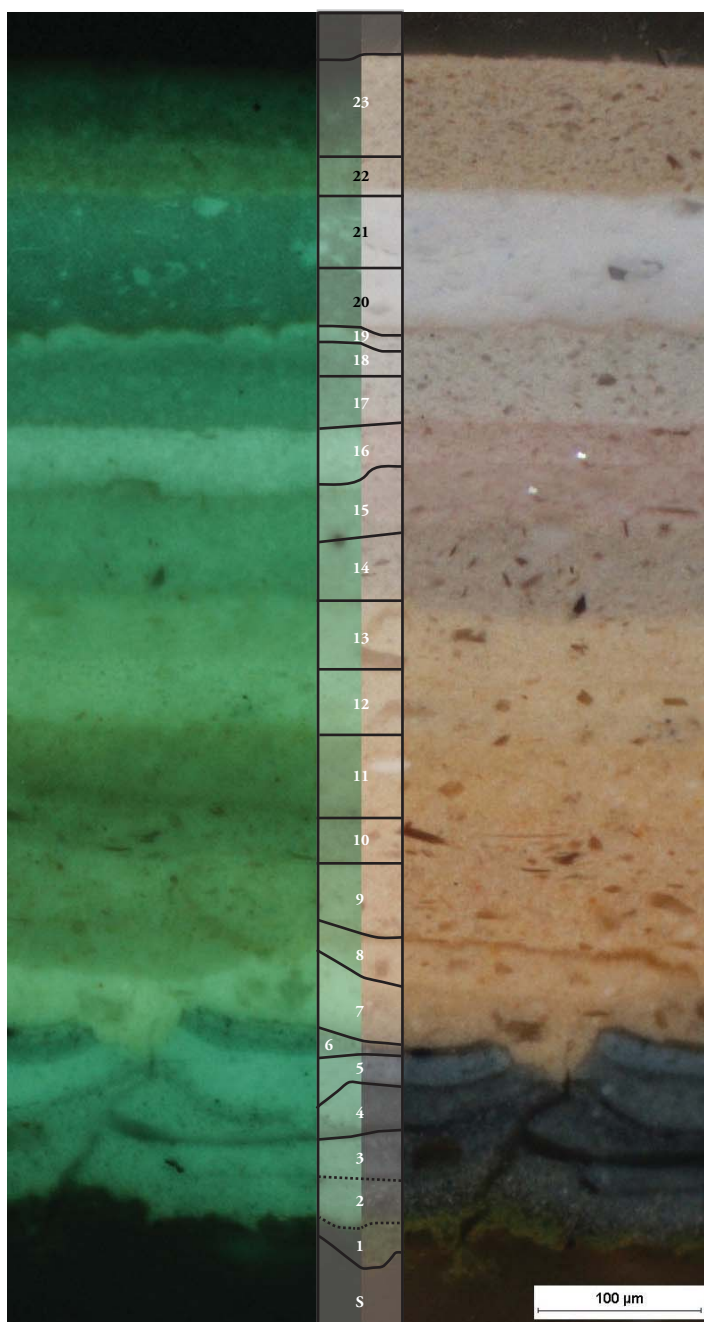
Guayama, Puerto Rico
48 N. Santiago Palmer Street

Sample Number: 48 :A: 2	Element: wall	Date Sampled: 02/13/11
Sample Location: siding at side elevation		Date Analyzed: 03/25/11
Substrate: wood	Illumination: Reflected/Quartz Halogen	
Microscope: Nikon ALPHAPHOT2-YS2		Objective: 10x
Analysis Performed by: Betty Prime		Camera: Nikon DS-Fi1

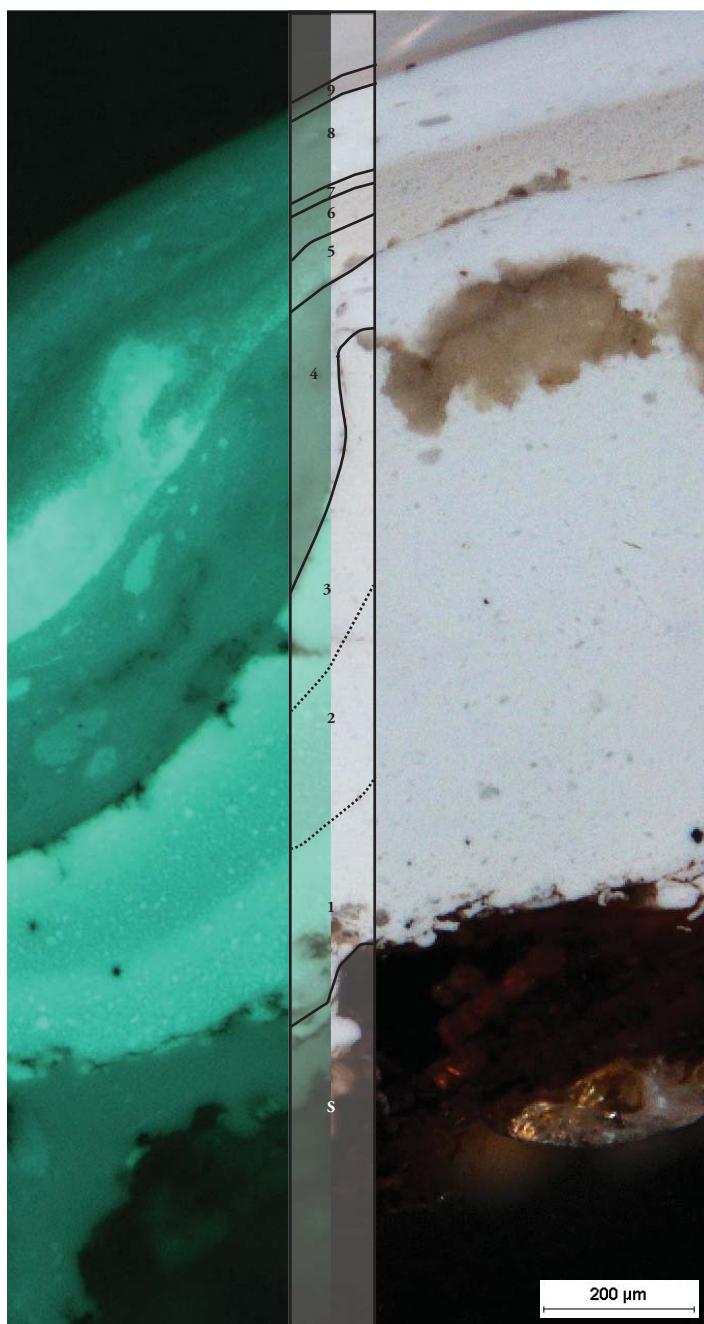
Guayama, Puerto Rico
48 N. Santiago Palmer Street

Sample Number: 48 :A: 4	Element: wall	Date Sampled: 02/13/11
Sample Location: cornerboard		Date Analyzed: 03/25/11
Substrate: wood	Illumination: Fluorescence BV 1A, Reflected/Quartz Halogen	
Microscope: Nikon ALPHAPHOT2-YS2		Objective: 4x
Analysis Performed by: Betty Prime		Camera: Nikon DS-Fi1

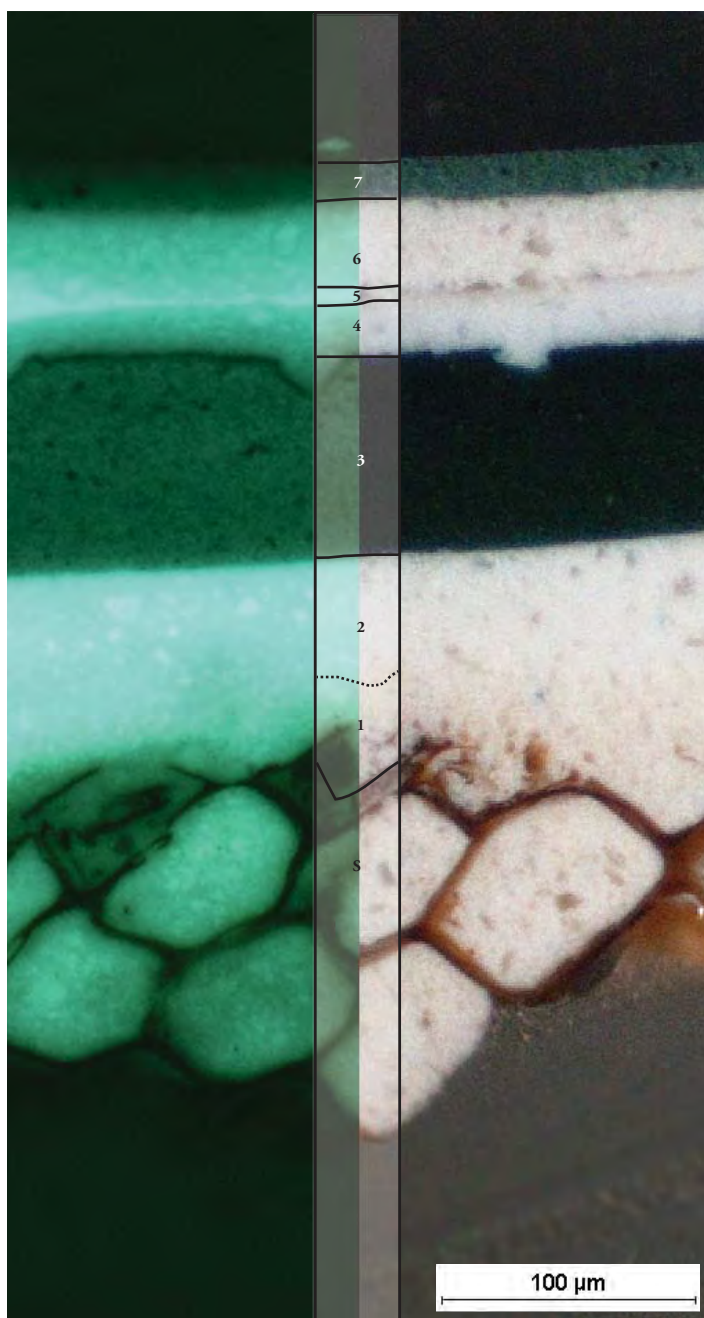
Guayama, Puerto Rico
48 N. Santiago Palmer Street

Sample Number: 48 :A: 6	Element: wall	Date Sampled: 02/13/11
Sample Location: baseboard		Date Analyzed: 03/25/11
Substrate: wood	Illumination: Fluorescence BV 1A, Reflected/Quartz Halogen	
Microscope: Nikon ALPHAPHOT2-YS2		Objective: 10x
Analysis Performed by: Betty Prime		Camera: Nikon DS-Fi1

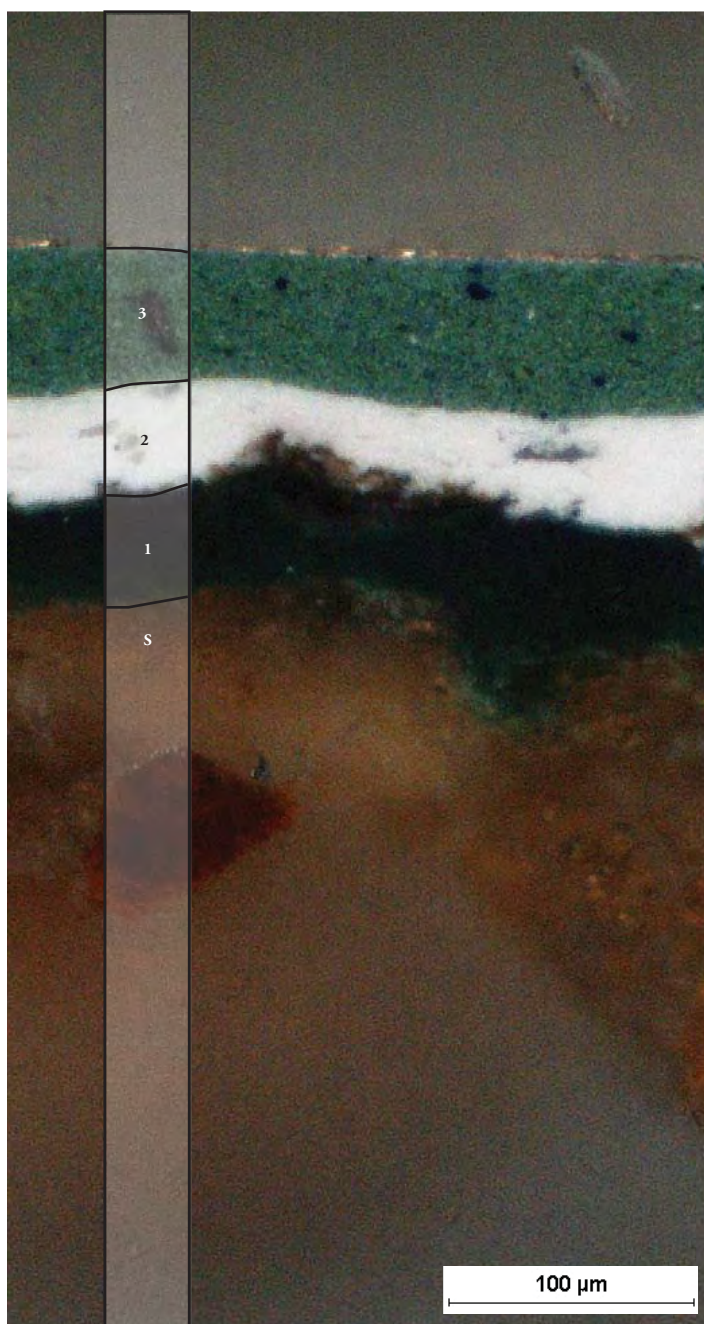
Guayama, Puerto Rico
48 N. Santiago Palmer Street

Sample Number: 48 :B: 1	Element: building base	Date Sampled: 02/13/11
Sample Location: far north		Date Analyzed: 03/25/11
Substrate: concrete	Illumination: Reflected/Quartz Halogen	
Microscope: Nikon ALPHAPHOT2-YS2		Objective: 10x
Analysis Performed by: Betty Prime		Camera: Nikon DS-Fi1

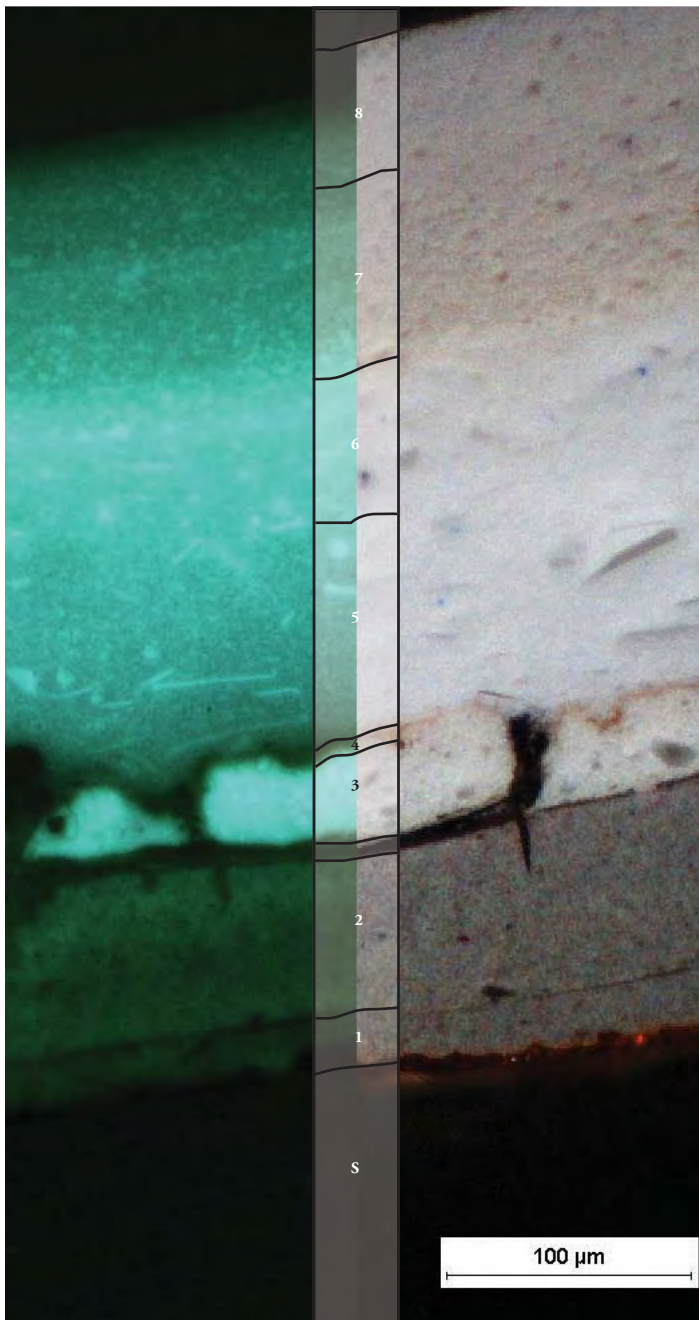
Guayama, Puerto Rico
48 N. Santiago Palmer Street

Sample Number: 48 :C: 1	Element: column	Date Sampled: 02/13/11
Sample Location: joint, 2nd to last from north side		Date Analyzed: 03/25/11
Substrate: galvanized metal	Illumination: Fluorescence BV 1A, Reflected/Quartz Halogen	
Microscope: Nikon ALPHAPHOT2-YS2		Objective: 10x
Analysis Performed by: Betty Prime		Camera: Nikon DS-Fi1

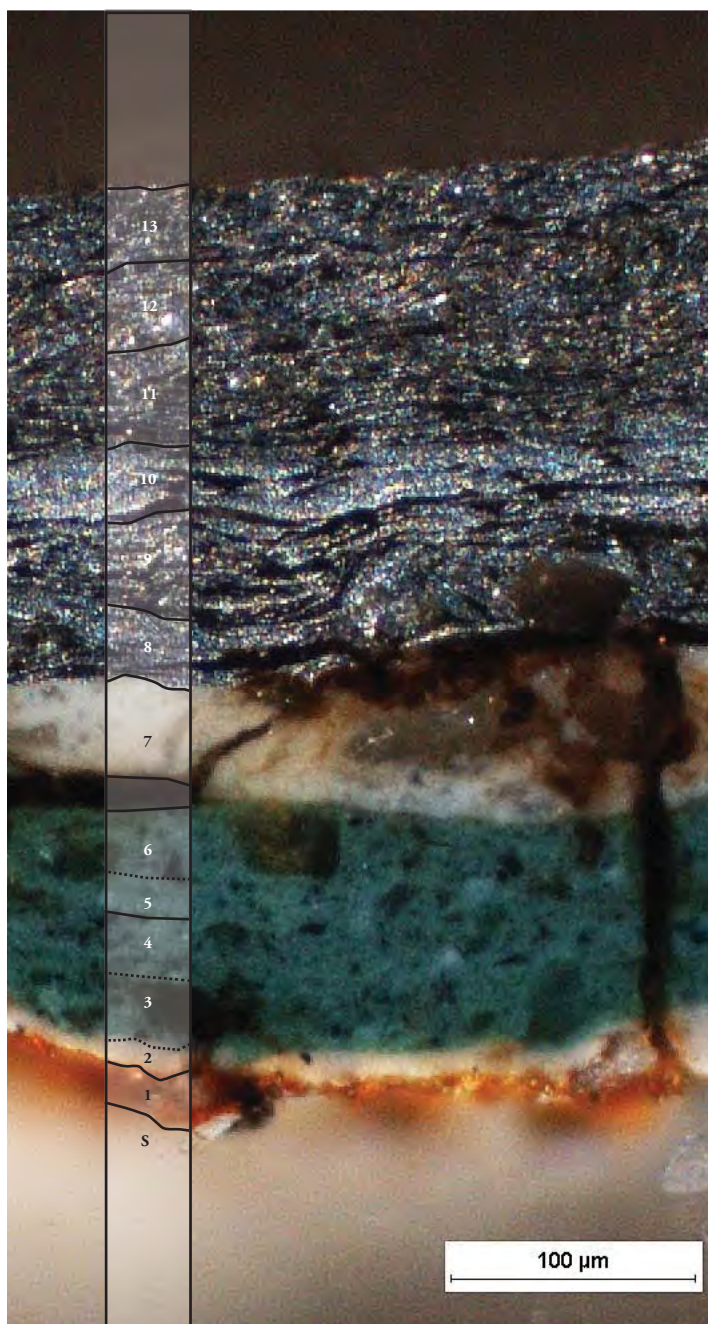
Guayama, Puerto Rico
48 N. Santiago Palmer Street

Sample Number: 48 :D: 2	Element: porch railing	Date Sampled: 02/13/11
Sample Location: middle		Date Analyzed: 03/25/11
Substrate: iron	Illumination: Reflected/Quartz Halogen	
Microscope: Nikon ALPHAPHOT2-YS2		Objective: 10x
Analysis Performed by: Betty Prime		Camera: Nikon DS-Fi1

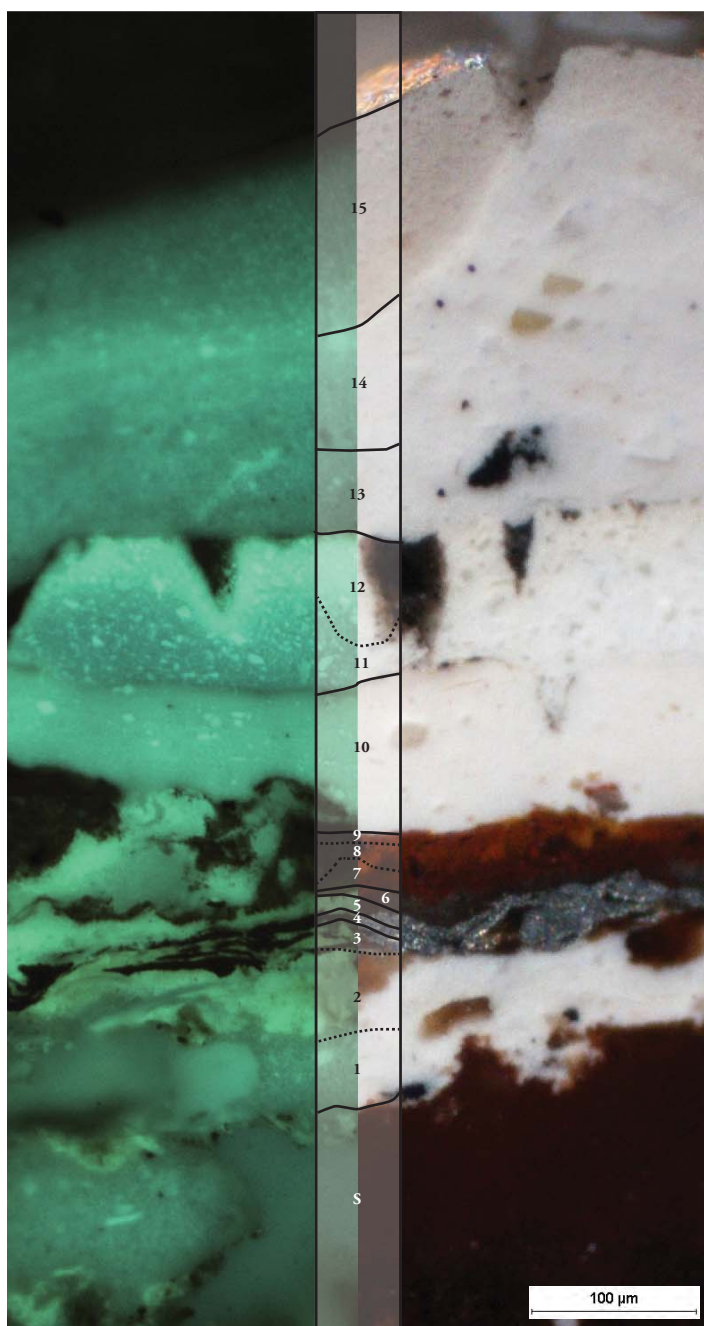
Guayama, Puerto Rico
48 N. Santiago Palmer Street

Sample Number: 48 :E: 1	Element: handrail	Date Sampled: 02/13/11
Sample Location: at door, first from left		Date Analyzed: 03/25/11
Substrate: wood	Illumination: Fluorescence BV 1A, Reflected/Quartz Halogen	
Microscope: Nikon ALPHAPHOT2-YS2		Objective: 10x
Analysis Performed by: Betty Prime		Camera: Nikon DS-Fi1

Scheme/Layer		Color
10	15	*cream
9	14	white
8	13	white
7	12	*off white
	11	white
6	10	*off white
5	9	yellow brown
	8	orange red
	7	red brown
4	6	dark grey
3	5	silver
2	4	silver
1	3	silver
	2	white
	1	white
		substrate

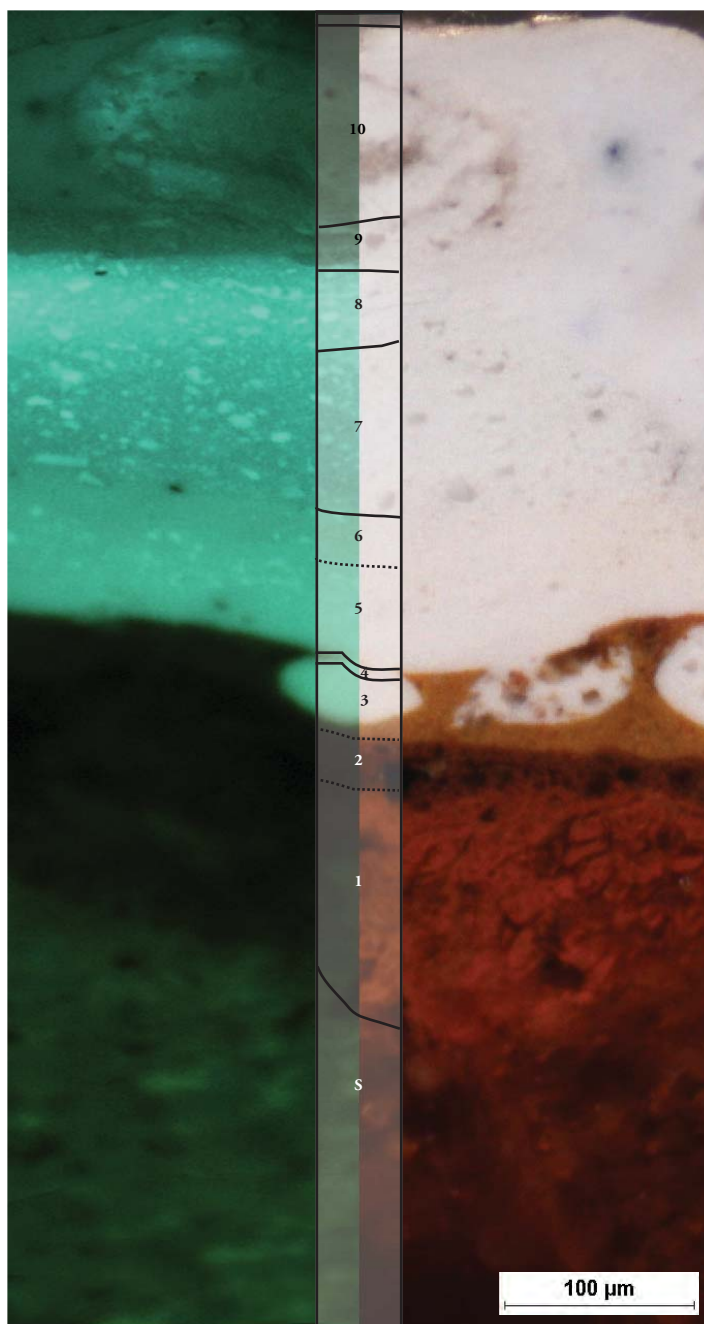
Guayama, Puerto Rico
48 N. Santiago Palmer Street

Sample Number: 48 :F: 5	Element: door	Date Sampled: 02/13/11
Sample Location: 2nd from north, bottom panel lft side		Date Analyzed: 03/25/11
Substrate: wood	Illumination: Fluorescence BV 1A, Reflected/Quartz Halogen	
Microscope: Nikon ALPHAPHOT2-YS2		Objective: 10x
Analysis Performed by: Betty Prime		Camera: Nikon DS-Fi1

7	10	pink white
6	9	pink white
5	8	white
4	7	yellow white
3	6	pink white
2	5	pink white
1	4	brown orange
	3	yellow brown
	2	brown
	1	rust red
		substrate

Munsell Color F1 : rust red- 10R 3/9
brown- 10R 2.5/4, brown yellow-10YR 5/10

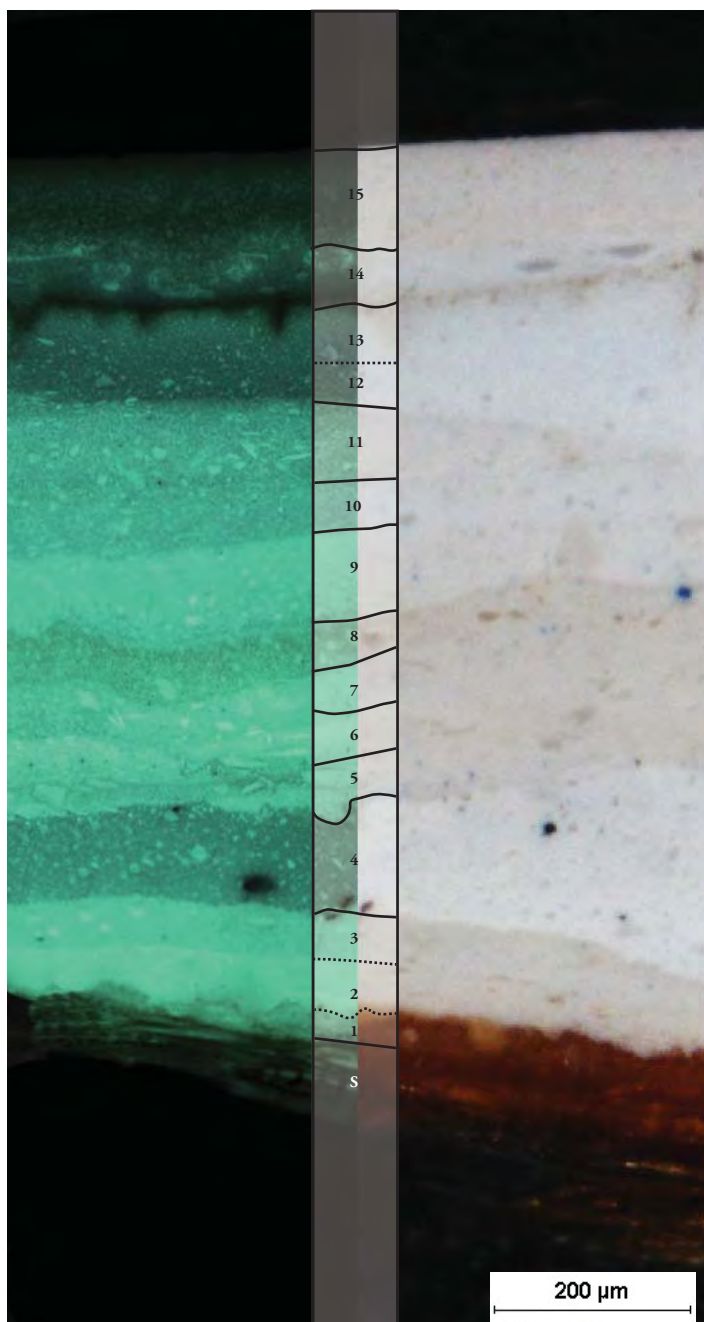
Guayama, Puerto Rico
48 N. Santiago Palmer Street

Sample Number: 48 :G: 6	Element: door frame	Date Sampled: 02/13/11
Sample Location: 3rd door from south		Date Analyzed: 03/25/11
Substrate: wood	Illumination: Fluorescence BV 1A, Reflected/Quartz Halogen	
Microscope: Nikon ALPHAPHOT2-YS2		Objective: 4x
Analysis Performed by: Betty Prime		Camera: Nikon DS-Fi1

Scheme/Layer		Color
12	15	off white
11	14	white
10	13	*white
	12	white
9	11	off white
8	10	off white
7	9	blue white
6	8	blue white
5	7	blue white
4	6	blue white
3	5	blue white
2	4	blue white
1	3	off white
	2	off white
	1	brown orange
		substrate

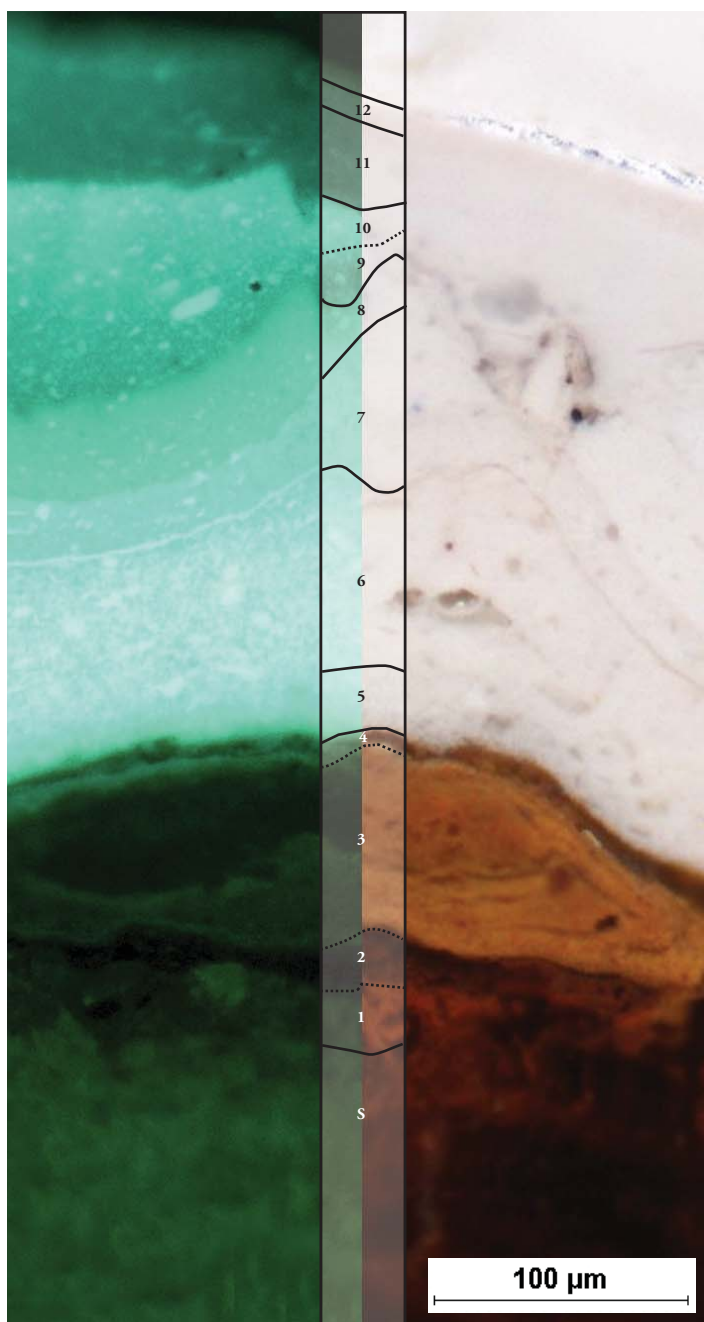
Guayama, Puerto Rico
48 N. Santiago Palmer Street

Sample Number: 48 :K: 1	Element: door shutter/louver	Date Sampled: 02/13/11
Sample Location: 2nd door from north		Date Analyzed: 03/25/11
Substrate: wood	Illumination: Fluorescence BV 1A, Reflected/Quartz Halogen	
Microscope: Nikon ALPHAPHOT2-YS2		Objective: 10x
Analysis Performed by: Betty Prime		Camera: Nikon DS-Fi1

Scheme/Layer		Color
8	12	pink white
7	11	off white
6	10	yellow white
	9	/*pink white
5	8	pink white
4	7	pink white
3	6	pink white
2	5	off white
1	4	/brown orange
	3	brown yellow
	2	brown
	1	rust red
		substrate

Munsell Color F1 : rust red- 10R 3/9
brown- 10R 2.5/4, brown yellow-10YR 5/10

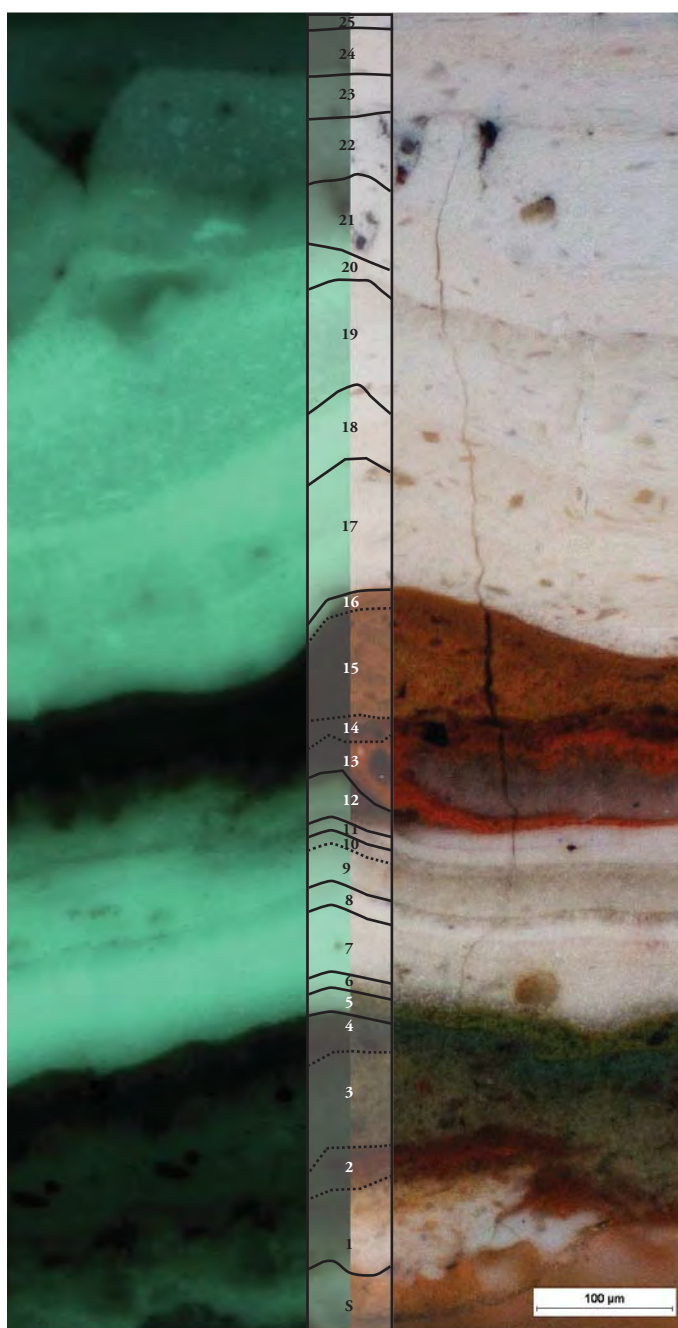
Guayama, Puerto Rico
48 N. Santiago Palmer Street

Sample Number: 48 :K: 3	Element: window shutter louvers	Date Sampled: 02/13/11
Sample Location: side elevation		Date Analyzed: 03/25/11
Substrate: wood	Illumination: Fluorescence BV 1A, Reflected/Quartz Halogen	
Microscope: Nikon ALPHAPHOT2-YS2		Objective: 10x
Analysis Performed by: Betty Prime		Camera: Nikon DS-Fi1

21	25	white
20	24	white
19	23	white
18	22	white
17	21	white
16	20	* white
15	19	white
14	18	white
13	17	orange brown
9	16	yellow brown
	15	brown
	14	rust red
	13	/ white
8	12	white
7	11	white
	10	white
6	9	white
5	8	white
4	7	white
3	6	/yellow green
2	5	green
1	4	green grey
	3	rust red
	2	white primer
	1	substrate

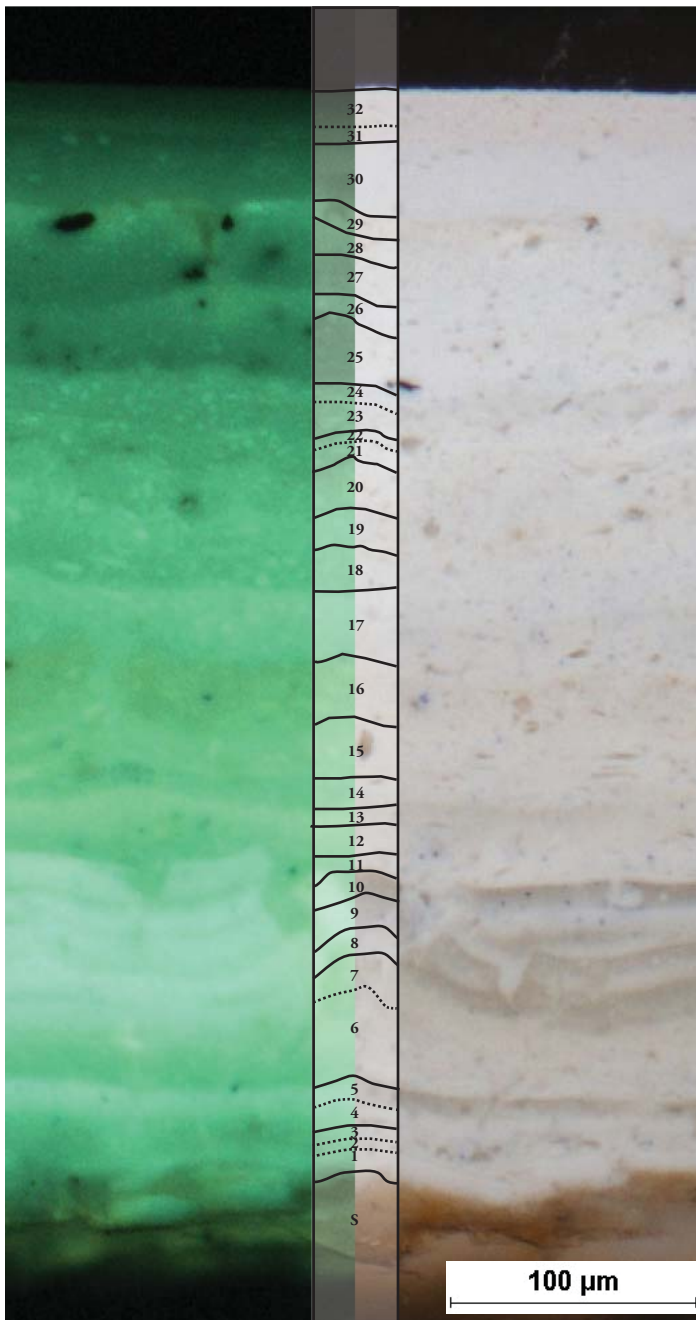
Guayama, Puerto Rico
48 N. Santiago Palmer Street

Sample Number: 48 :H: 2	Element: cornice/soffit	Date Sampled: 02/13/11
Sample Location: cornice, middle flat section		Date Analyzed: 03/25/11
Substrate: wood	Illumination: Fluorescence BV 1A, Reflected/Quartz Halogen	
Microscope: Nikon ALPHAPHOT2-YS2		Objective: 10x
Analysis Performed by: Betty Prime		Camera: Nikon DS-Fi1

Scheme/Layer		Color
19	25	light cream
18	24	light tan
	23	off white
17	22	off white
	21	off white
16	20	off white
15	19	light cream
14	18	off white
13	17	off white
12	16	cream
11	15	off white
10	14	off white
9	13	light tan
8	12	light tan
7	11	off white
6	10	*blue white
5	9	white
4	8	off white
3	7	light cream
	6	off white
2	5	*off white
	4	off white
1	3	off white
	2	white
	1	white
		substrate

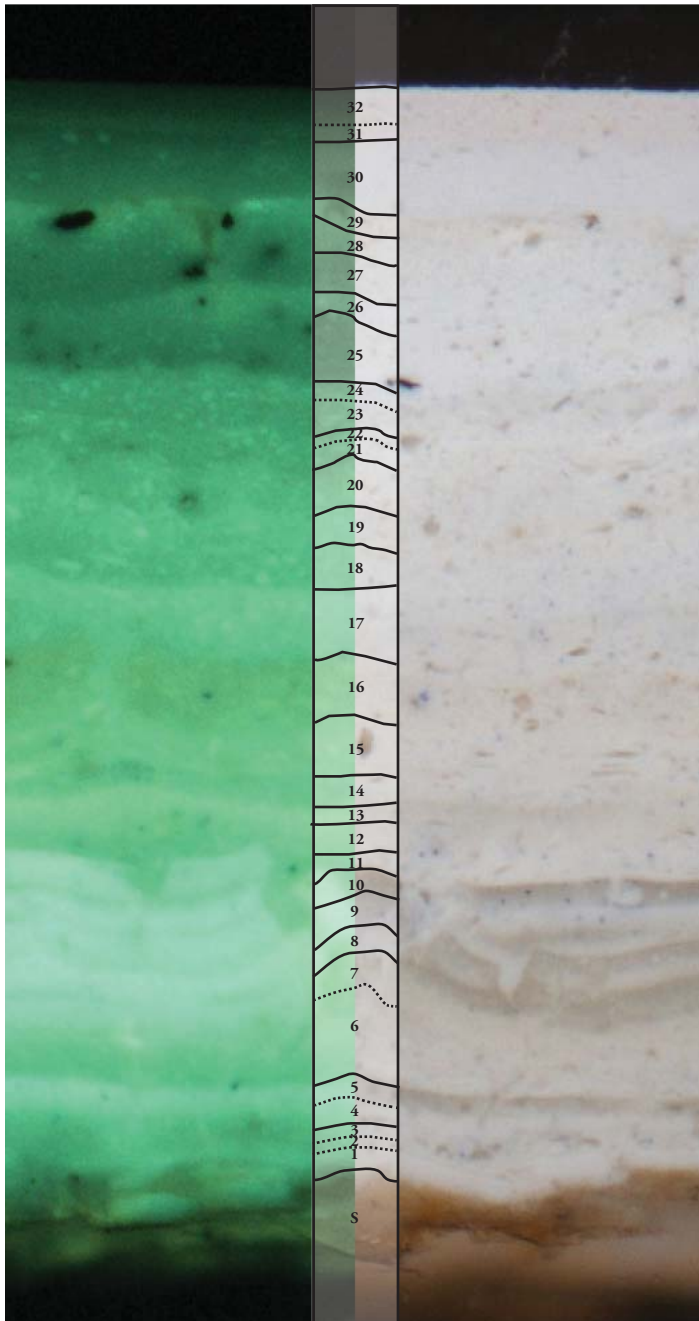
Guayama, Puerto Rico
48 N. Santiago Palmer Street

Sample Number: 48 :H: 2	Element: cornice/soffit	Date Sampled: 02/13/11
Sample Location: cornice, middle flat section		Date Analyzed: 03/25/11
Substrate: wood	Illumination: Fluorescence BV 1A, Reflected/Quartz Halogen	
Microscope: Nikon ALPHAPHOT2-YS2		Objective: 10x
Analysis Performed by: Betty Prime		Camera: Nikon DS-Fi1
